WATER ASSESSMENT REPORT

Southgate Solar Project

DRAFT– December 2014

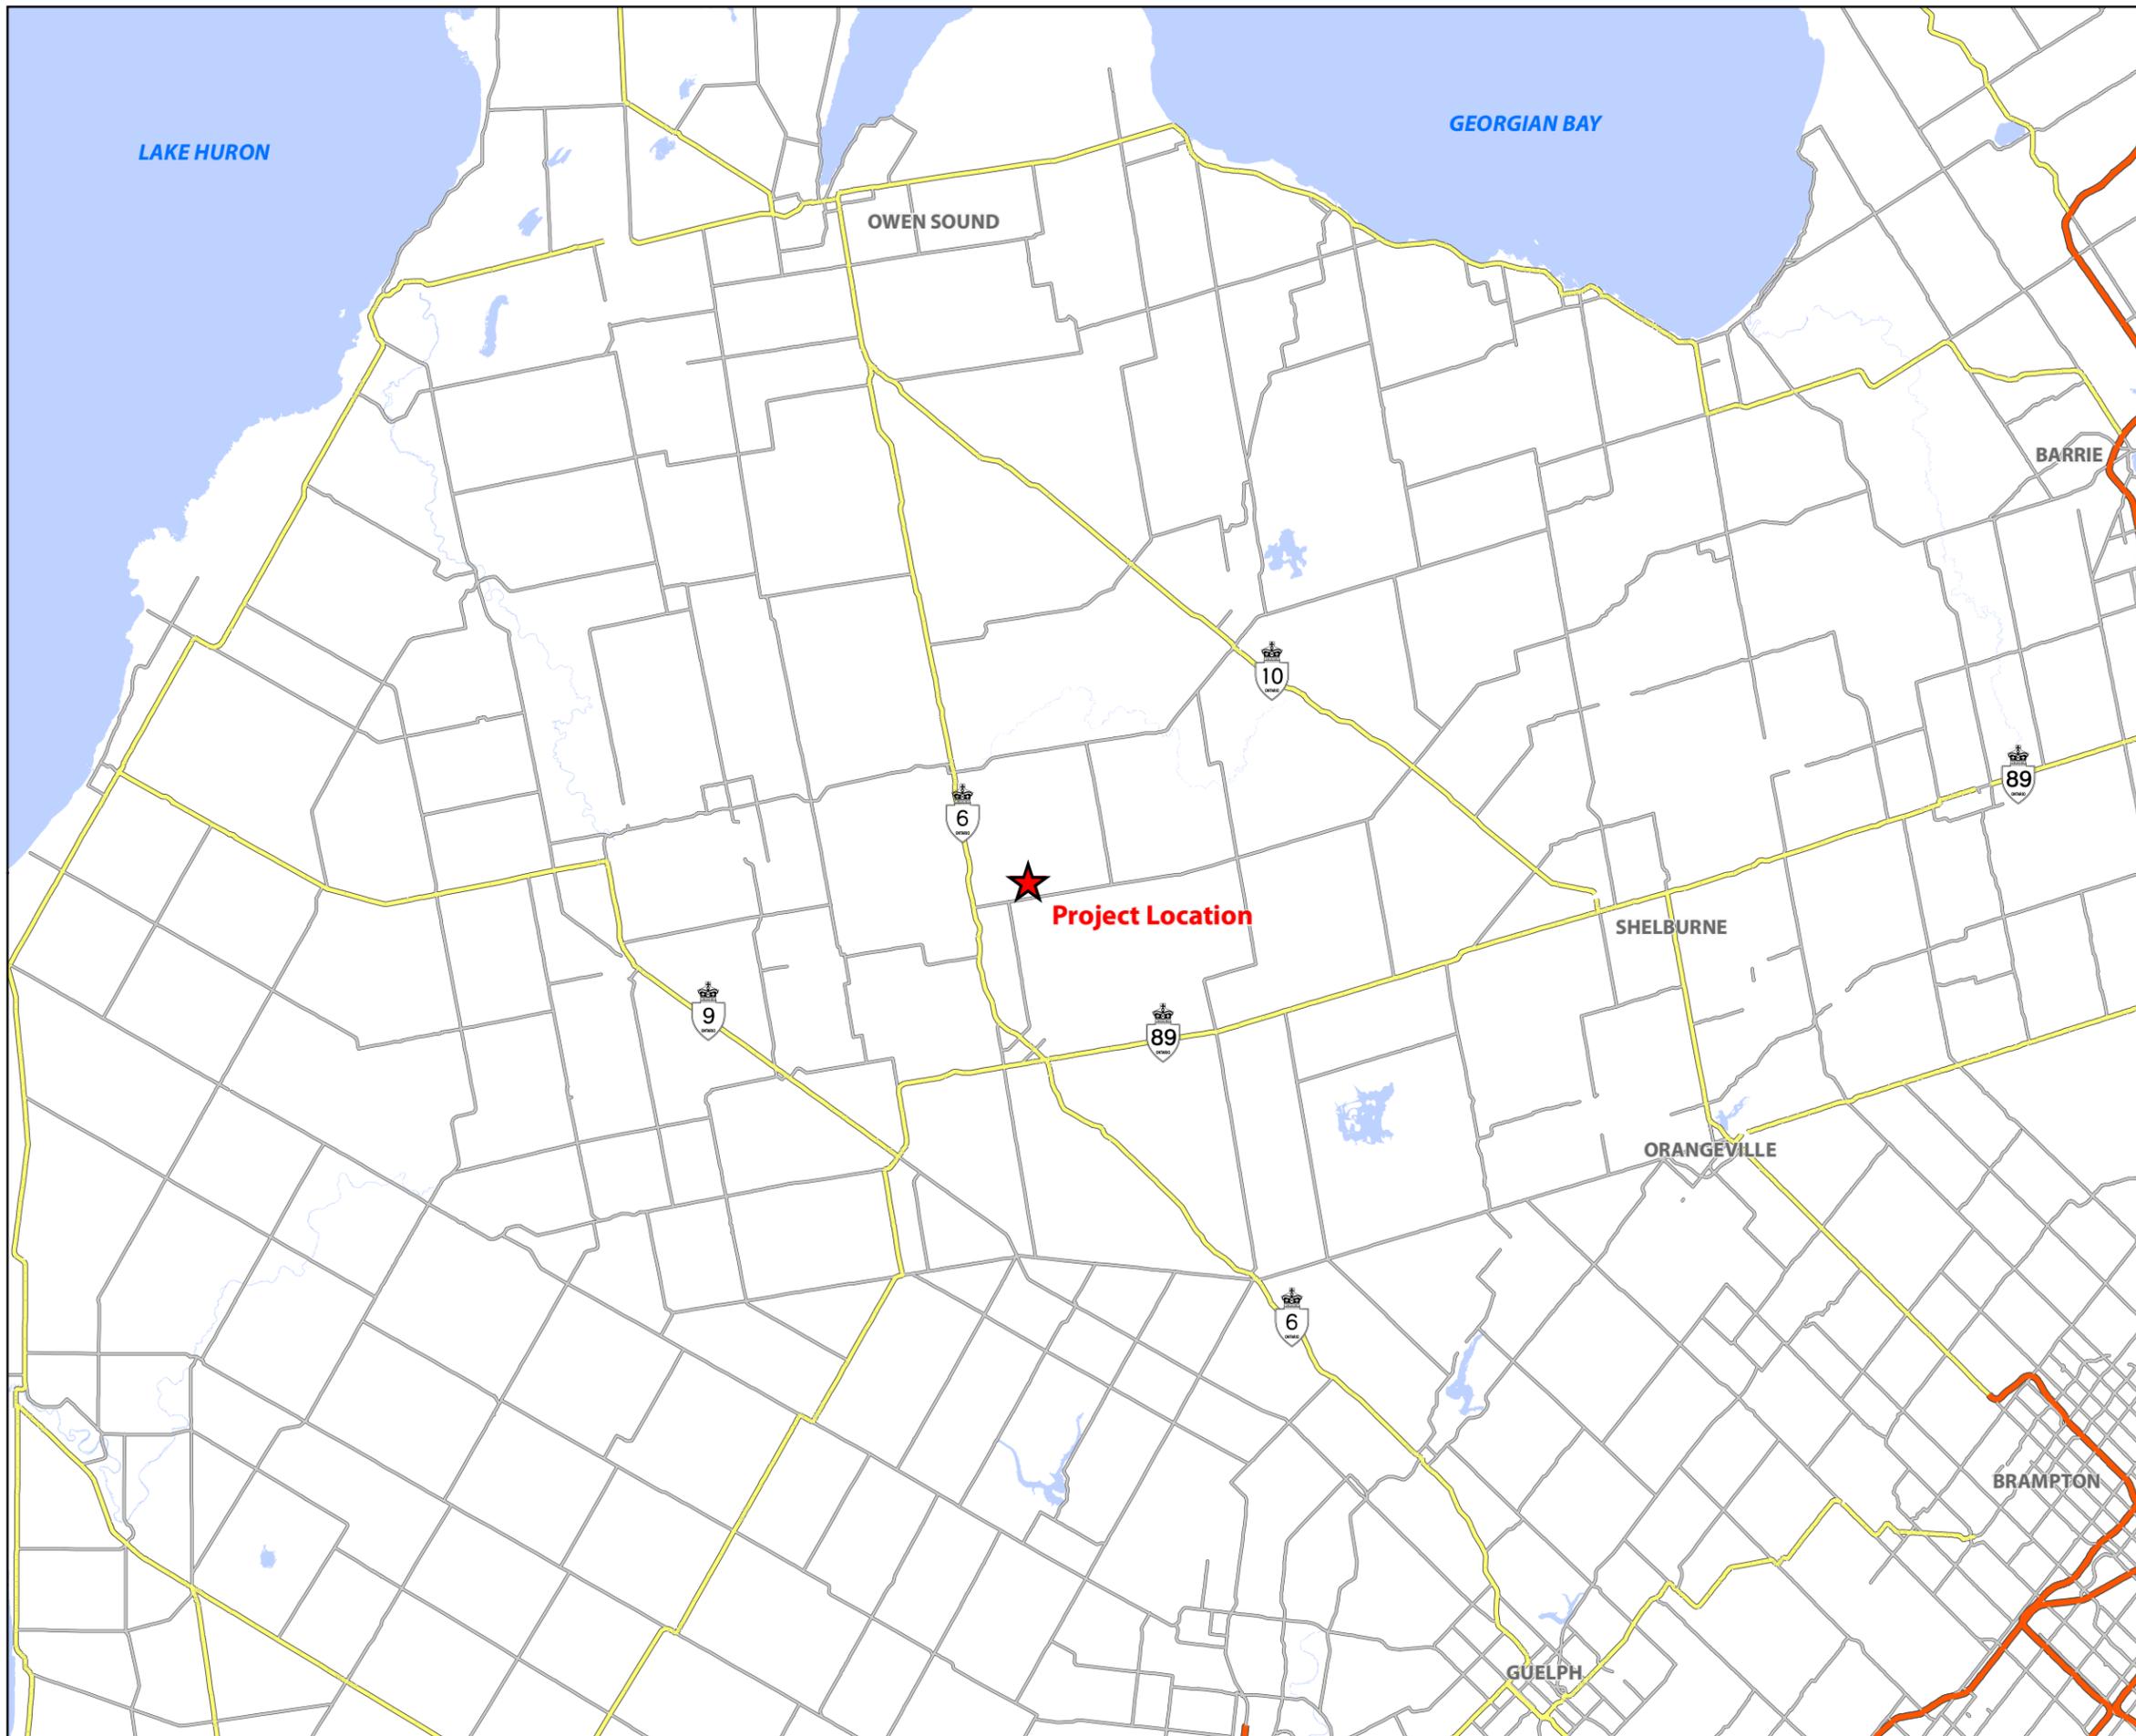
**FIGURE 1
GENERAL PROJECT LOCATION**

Figure 1 shows the general location of the Project in Ontario. The Project Location is defined in *Ontario Regulation 359/09* to be “a part of land and all or part of any building or structure in, on or over which a person is engaging in or proposes to engage in the project”.

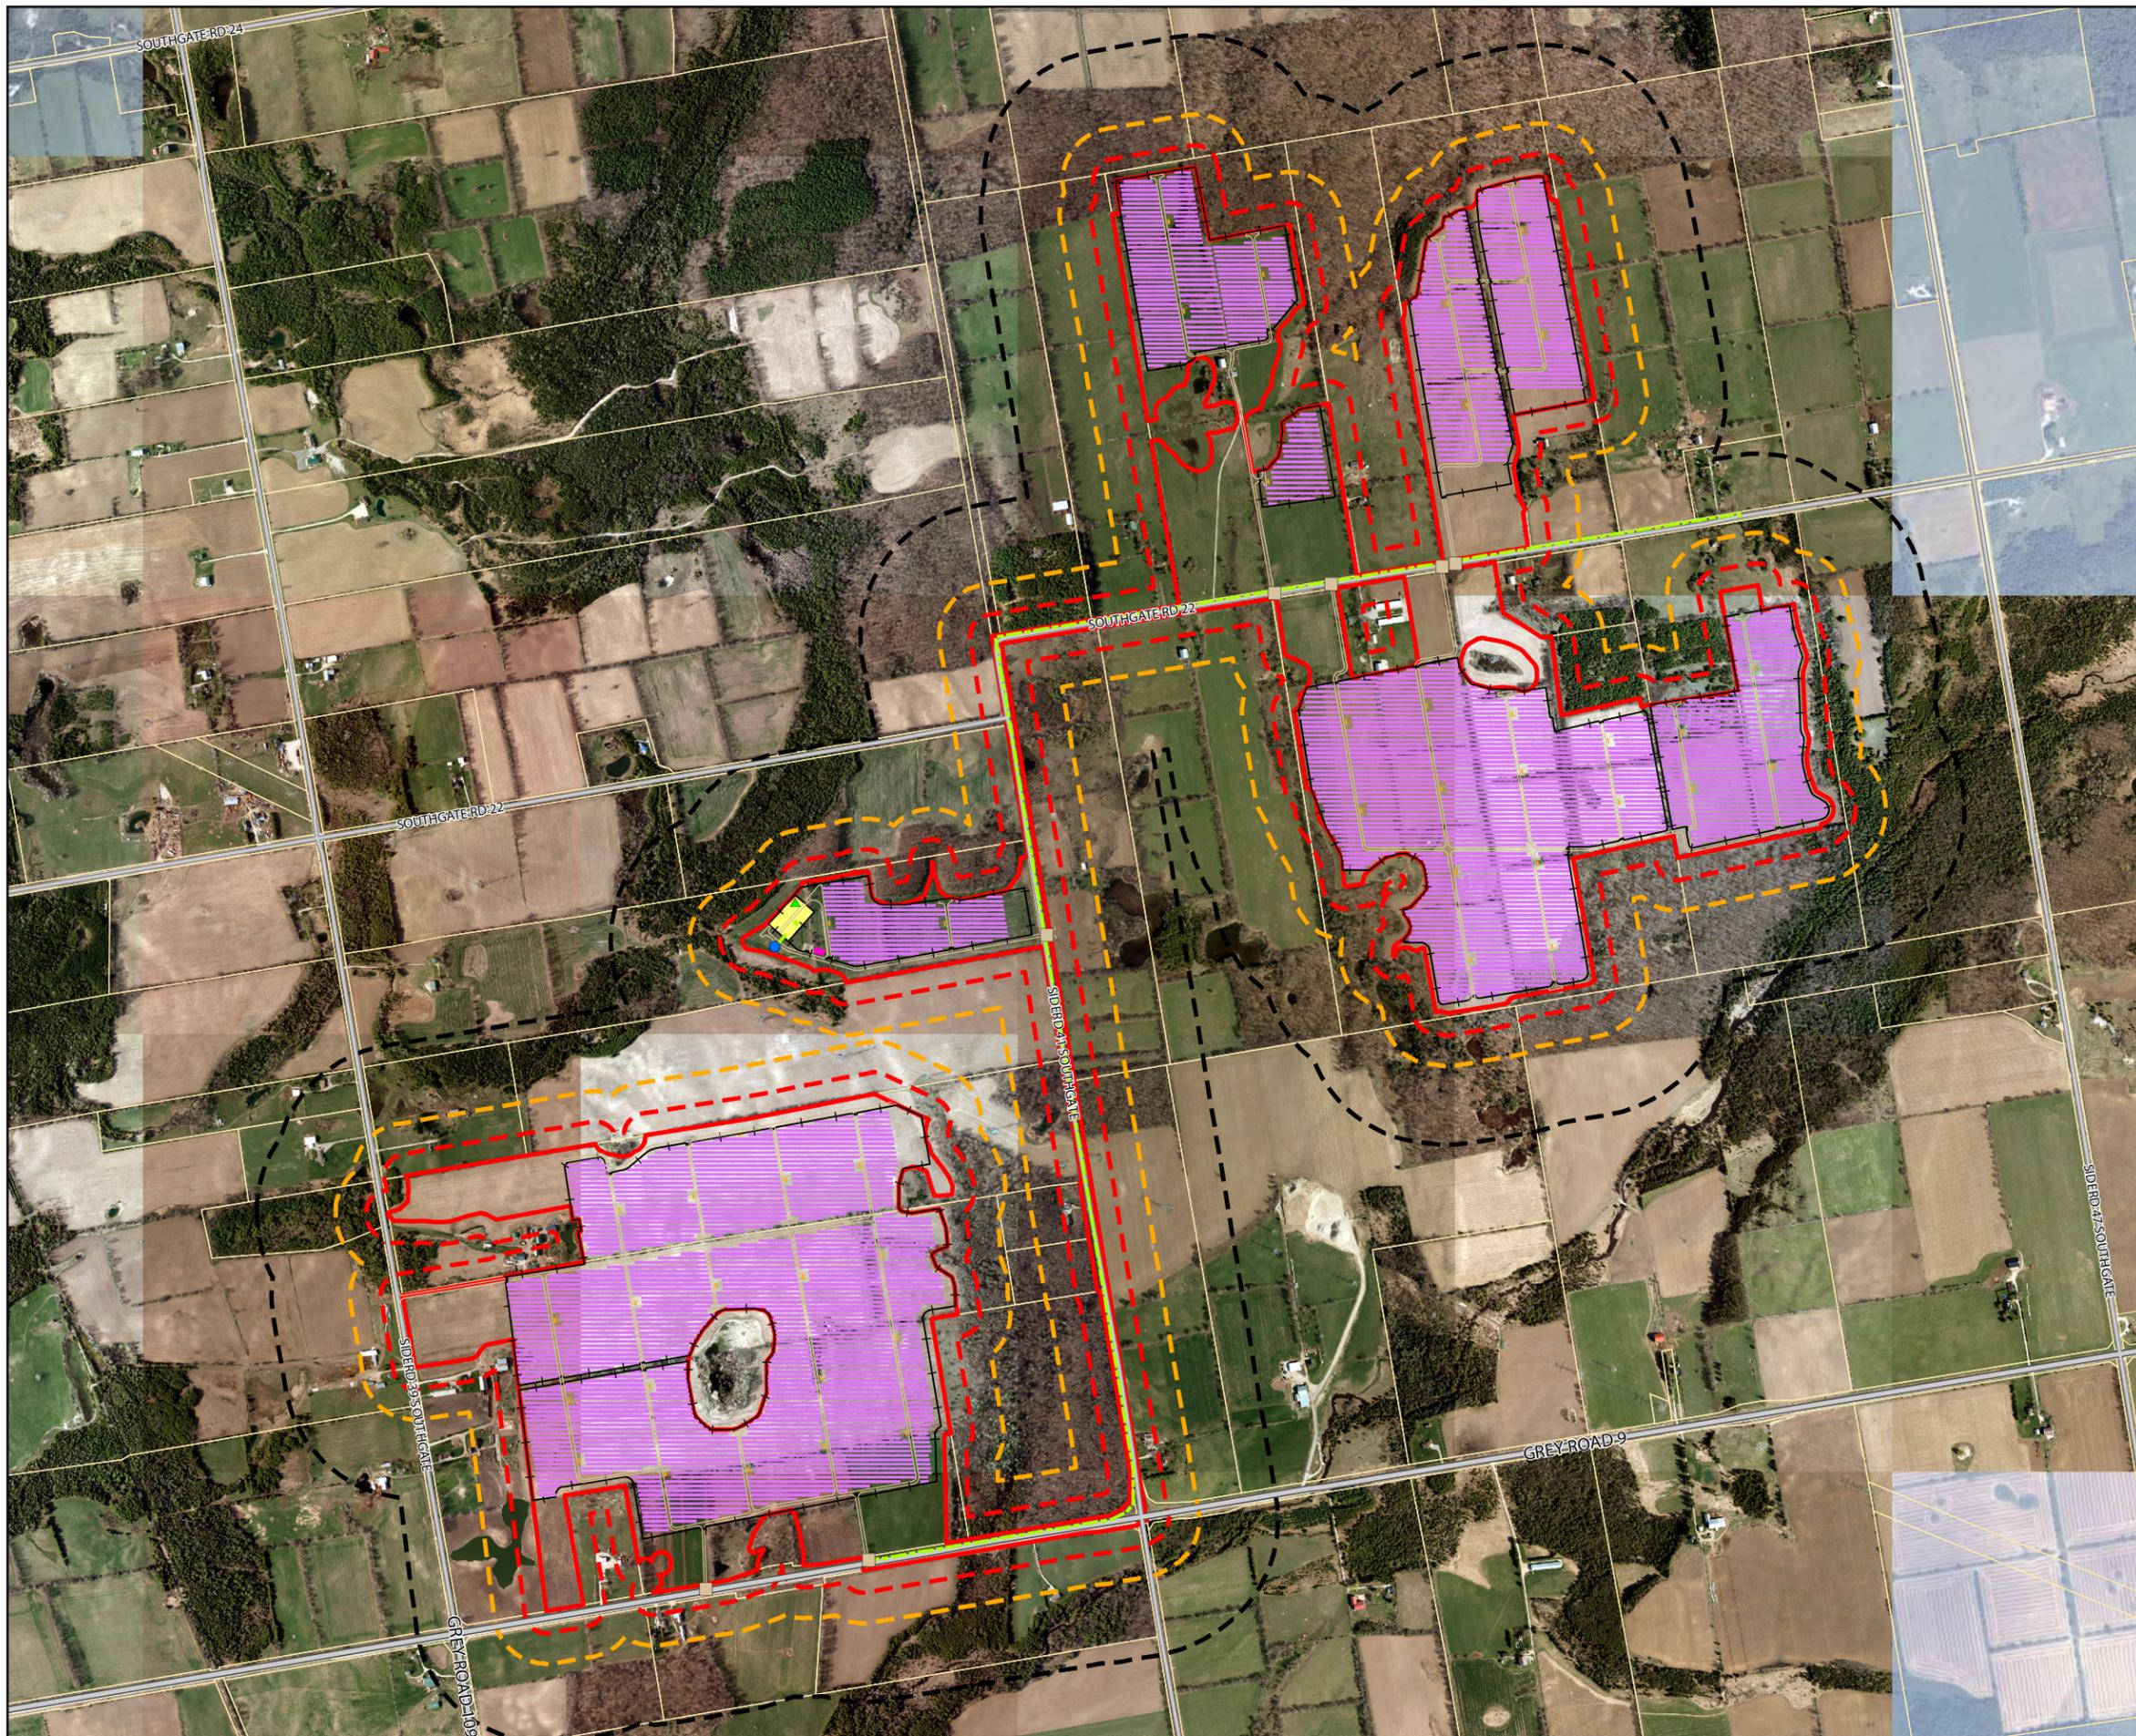
**FIGURE 2
PROJECT LOCATION**

Figure 2 shows the Project Location as defined by *Ontario Regulation 359/09*. Project components, including solar modules and electrical facilities such as Medium Voltage (MV) Stations, main high-voltage (HV) substation transformer and electrical lines, will be located on private land. Areas within the Project Location but outside of the perimeter fence are “Areas of Operational Flexibility”. These areas have been reserved to accommodate other Project requirements (ex. stormwater measures, temporary laydown areas, etc.). This is discussed in greater detail in Section 4 of the *Project Description Report*. **Figure 2** also includes the 50 m, 120 m and 300 m setbacks from the Project Location. Each setback distance is applicable to various components of the REA process. The 120 m setback is applicable to the *Water Assessment Report*. The 50 m setback is only applicable to the *Natural Heritage Assessment* for the Project. The 300 m setback is shown in the mapping for reference in the *Construction Plan Report*. Setback development prohibitions for solar facilities are outlined in Part V, Sections 39 and 40 of *Ontario Regulation 359/09* (last amended May 2, 2014).

The area between the fence line and the Project Location is the Area of Operational Flexibility.

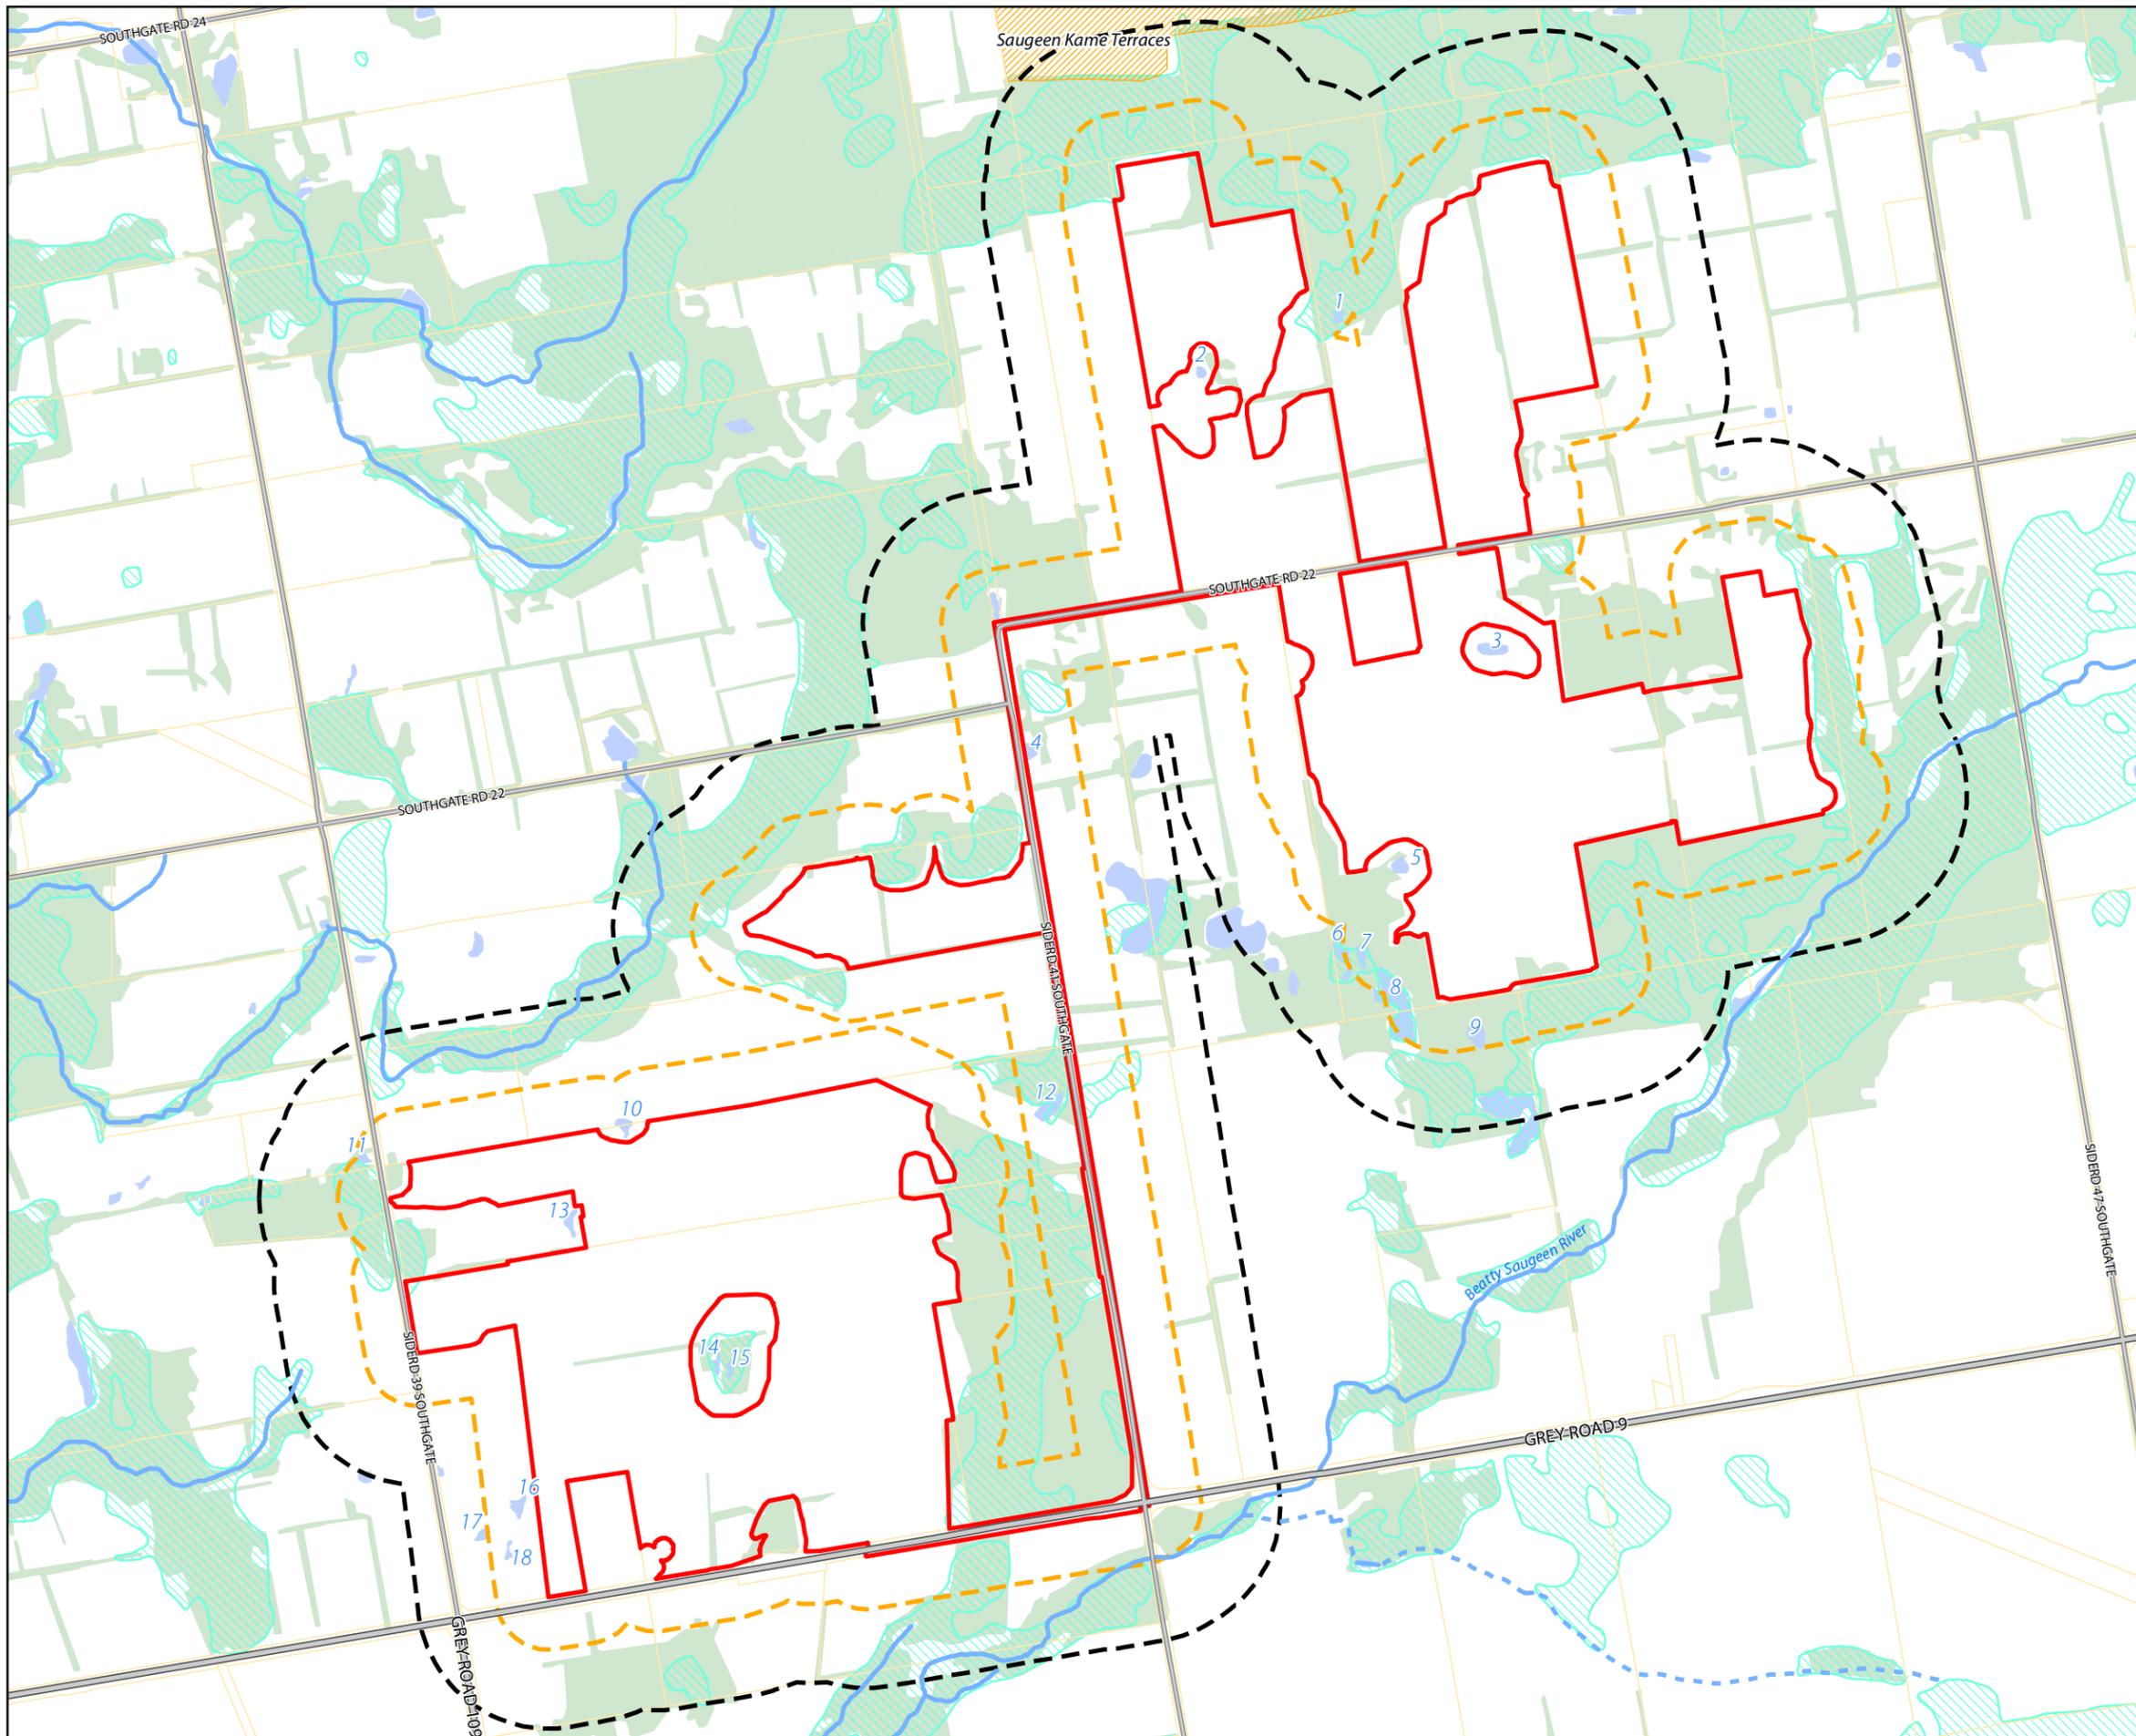
**FIGURE 3
RECORDS REVIEW**

Figure 3 shows the water bodies that were identified in the records review, and that have potential to occur within the Project Location or within the surrounding 120 m.

As shown on **Figure 3**, a records review was completed in accordance with Section 30 of *Ontario Regulation 359/09* using secondary source information.

A search and analysis of records and resources outlined in **Table 2** did not identify any mapped streams within the Project Location. One potential permanent stream is mapped within 120 m of the Project Location (**Figure 3**). The Beatty Saugeen River has been mapped by the MNR as a permanent stream (see **Figure 3** and **Appendix A**) approximately 120 m south of the southern boundary of the Project Location near the intersection of Grey Road 9 and Southgate Side Road 41 (**Figure 3**).

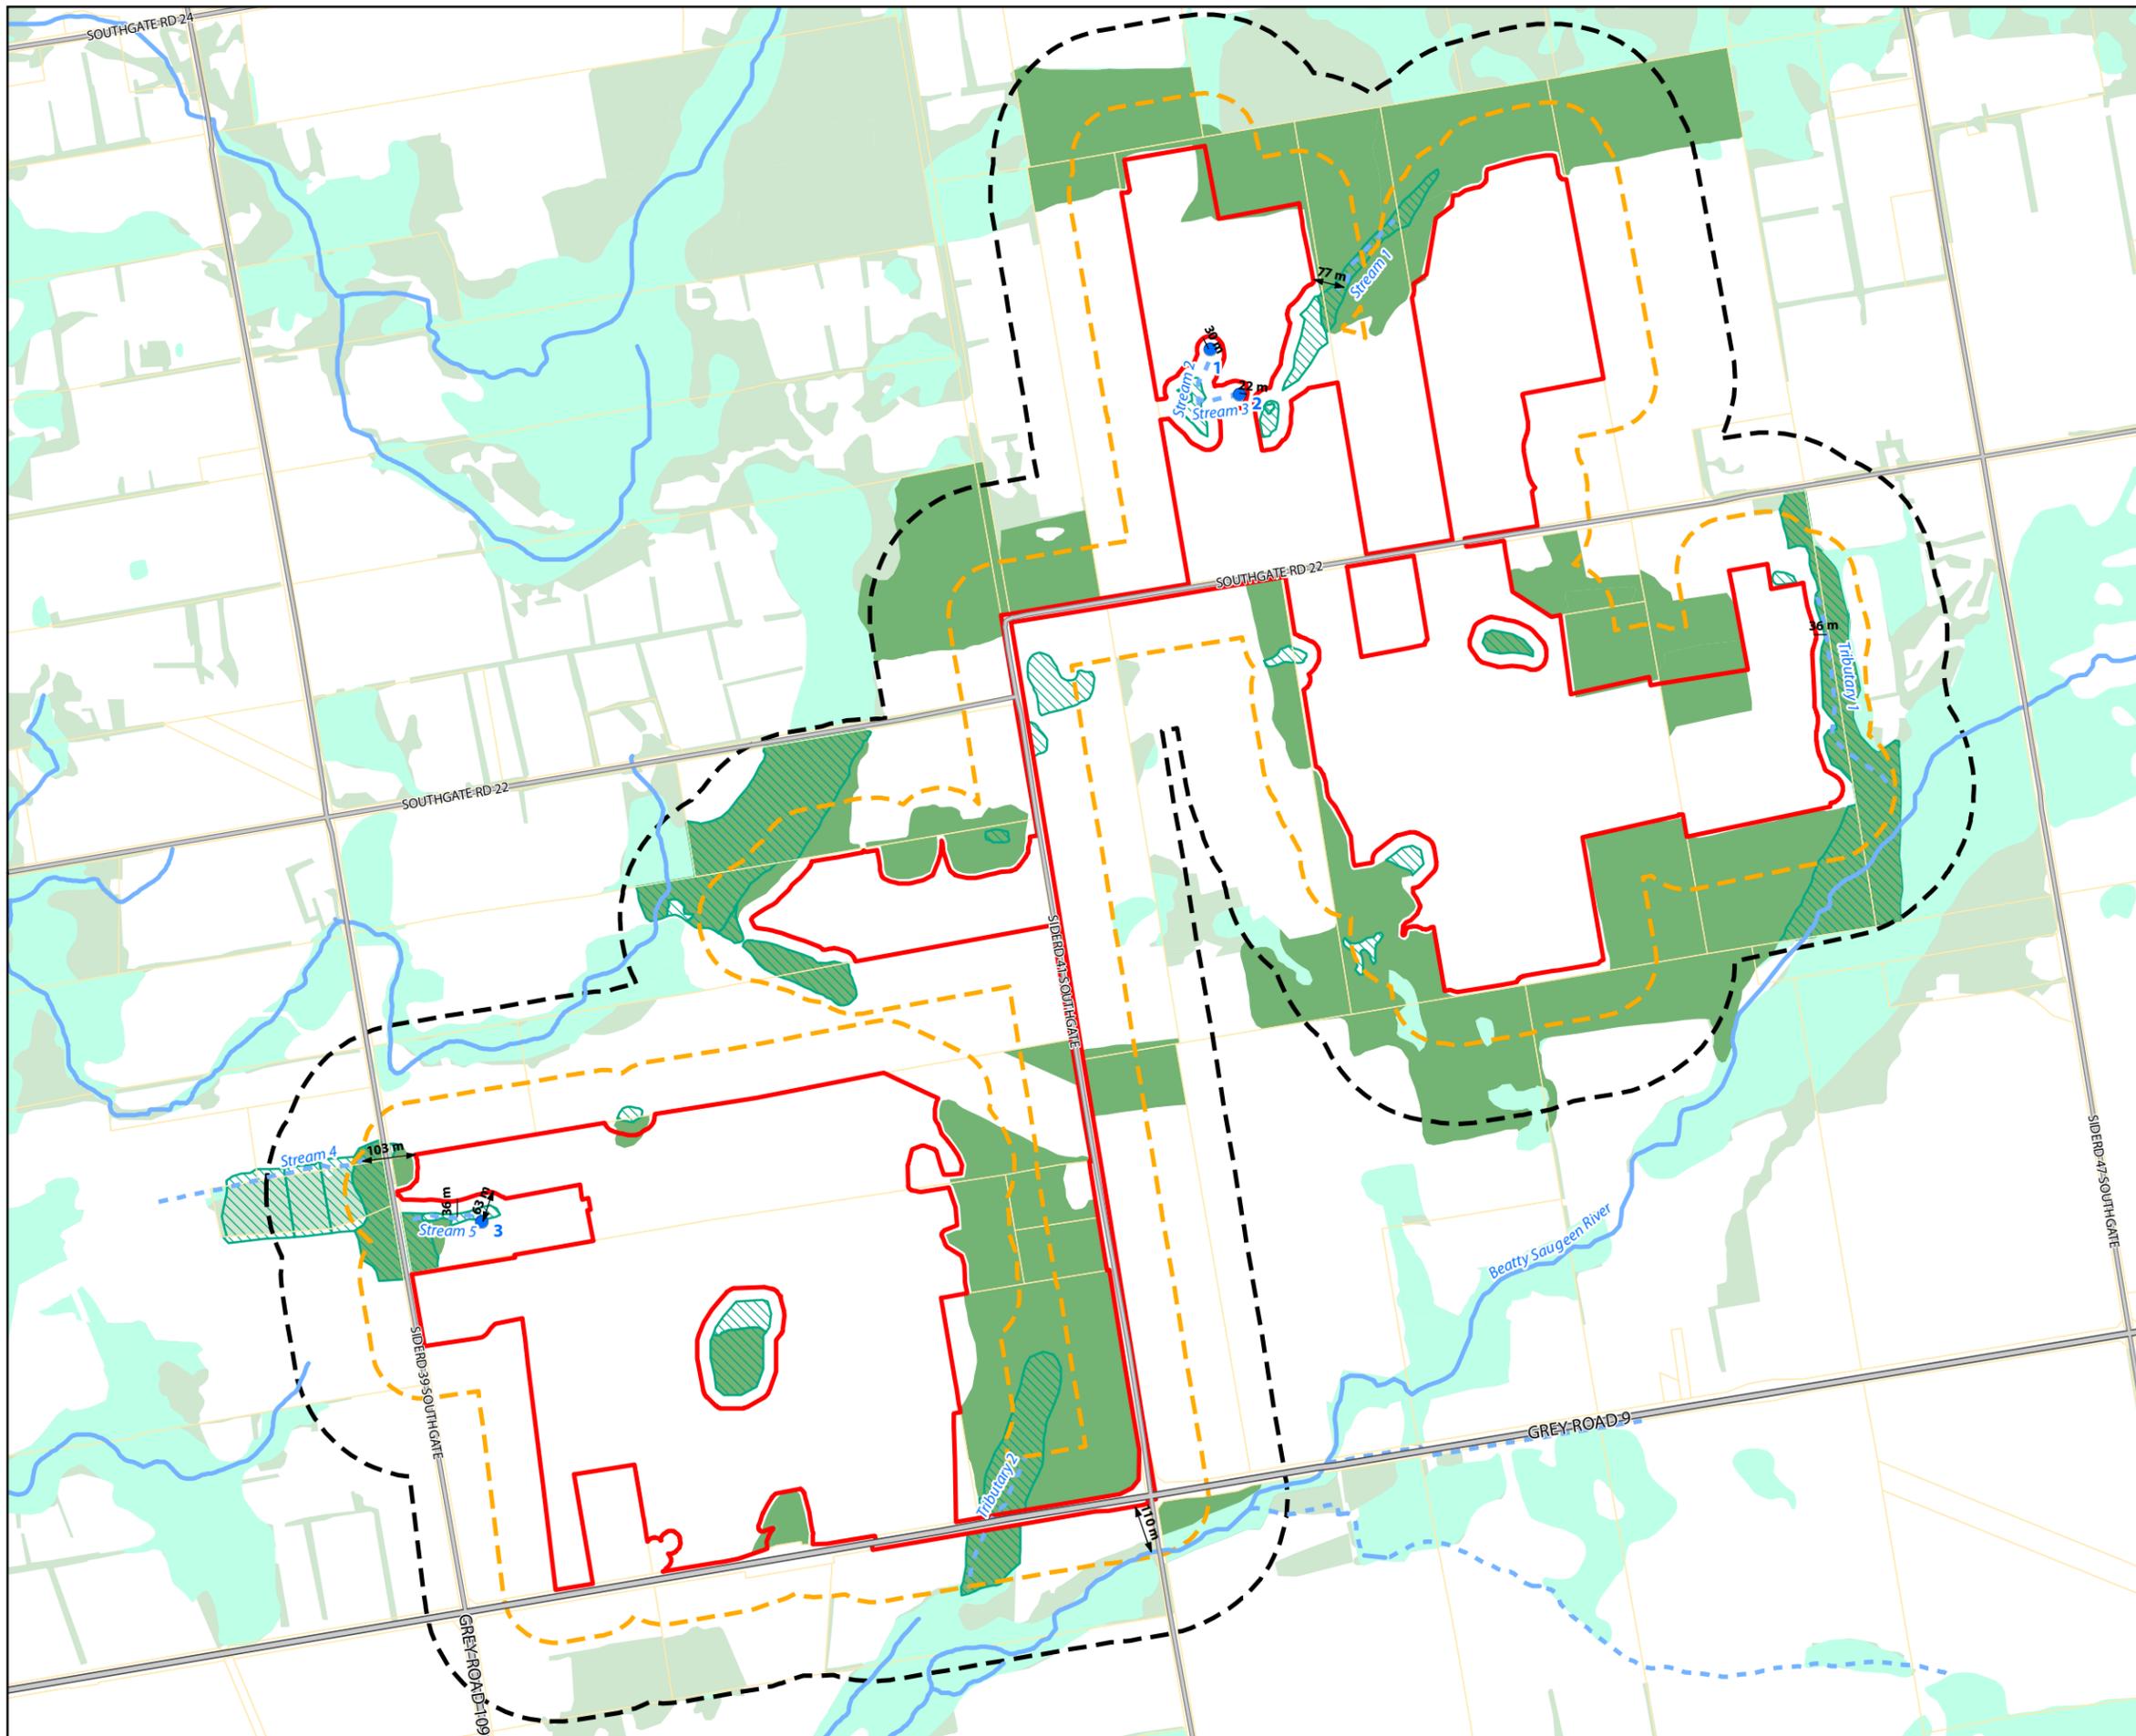
**FIGURE 4
WATER ASSESSMENT
SITE INVESTIGATION**

Figure 4 identifies natural features and water bodies based on the Water Assessment Site Investigation and the Natural Heritage Assessment.

The site investigation found the Beatty Saugeen River (hereafter referred to as “the River”) occurred as mapped by the MNRF and presented in the records review (**Figure 3**). It originates northeast of the Project Location, flows generally in a south-west direction, enters the 120 m setback at a location approximately 120 m south of the southern boundary of the Project Location near the intersection of Grey Road 9 and Southgate Side Road 41, flows westward, crosses under Southgate Side Road 41 via a bridge, then exits the 120 m setback approximately 50 m west of Southgate Side Road 41 (**Figure 4**).

Seepage Area 1 was found during the site investigation to occur within the 120 m setback, near the northwest area of the Project Location (44° 06' 49.15" N, 80° 44' 39.63" W, **Figure 4**). It occurred as a point source of groundwater emerging from the ground near a fence line adjacent to a cattle pasture (**Photograph 28** in **Appendix D**). The Seepage Area was surrounded by a horizontal circular steel cylinder with an approximate diameter of 1 m, set into a substrate base of sand, gravel and organic soil (**Photograph 42** in **Appendix D**). Groundwater was emerging from the substrates, filling the cylinder, flowing over its wall and feeding Stream 2.

Seepage Area 2 was found during the site investigation to occur within 120 m setback, near the northwest area of the Project Location (44° 06' 45.89" N, 80° 44' 37.83" W, **Figure 4**), approximately 120 m southeast of Seepage Area 1. It occurred as a point source of groundwater emerging from the ground in a cattle pasture (**Photograph 31** in **Appendix D**). The Seepage Area was surrounded by a horizontal circular steel cylinder with an approximate diameter of 1 m, set into a substrate base of sand, gravel and organic soil (**Photograph 43** in **Appendix D**). Groundwater was emerging from the substrates, filling the cylinder, flowing over its wall and feeding Stream 3.

Seepage Area 3 was found during the site investigation to occur within the 120 m setback, near the western portion of the Project Location (44° 05' 44.26" N, 80° 45' 56.72" W, **Figure 4**). It occurred as a single point source of groundwater emerging from a west-facing hillside on a residential lawn, approximately 30 m west of a house (**Photograph 38** in **Appendix D**). The Seepage Area was surrounded by a horizontal circular concrete cylinder with an approximate diameter of 1.0 m, set into a substrate base of sand and gravel (**Photograph 44** in **Appendix D**). Groundwater was emerging from the substrates, filling the concrete cylinder, flowing over its wall and feeding Stream 5. The Seepage Area and concrete cylinder were covered by a constructed wood roof. A drainage pipe (0.1 m diameter) was also contained under the roof, emerging from the hillside and from the direction of the house, and was suspected to be a sump pump outlet drain from the house. It was not flowing at the time of site investigation.
